## 9992-DEC Firmware Version 0.8.X Release Notes

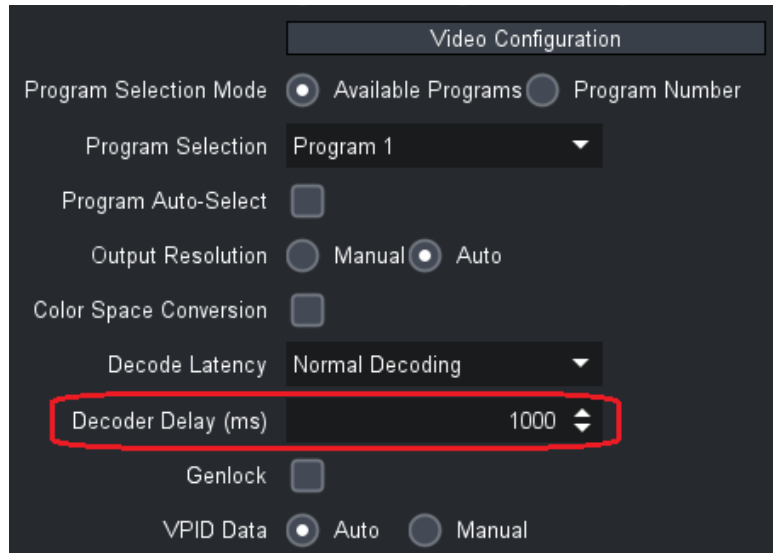
- This version corrects an issue whereby the decoder channel could occasionally lock up and go to black if the input signal were grossly out of audio timing model compliance. This issue would not happen with compliant signals.
- Previous versions would continuously restart the channel when the input is out of audio model compliance (i.e., video too far ahead of audio). This version will play the content without A/V sync, and will raise a yellow alarm in the **Decoder Status** field:

Decoder 1 Status	<span style="color: yellow;">●</span> Audio 1 Sync Error
ASI Redundancy	Off
Bit Rate (b/s)	588,047
Video Signal	1920x1080i29.97 4:2:0 8-bit
Program	1

If this alarm is raised, it may be possible to clear this situation by increasing the **Decoder Delay** until the problem clears. Note that changing the **Decoder Delay** causes the channel to restart.
